**BLACKSTONE RIVER BASIN
WORCESTER, MASSACHUSETTS**

**COOK POND DAM
MA 00123**

PHASE I INSPECTION REPORT NATIONAL DAM INSPECTION PROGRAM

AUGUST, 1978

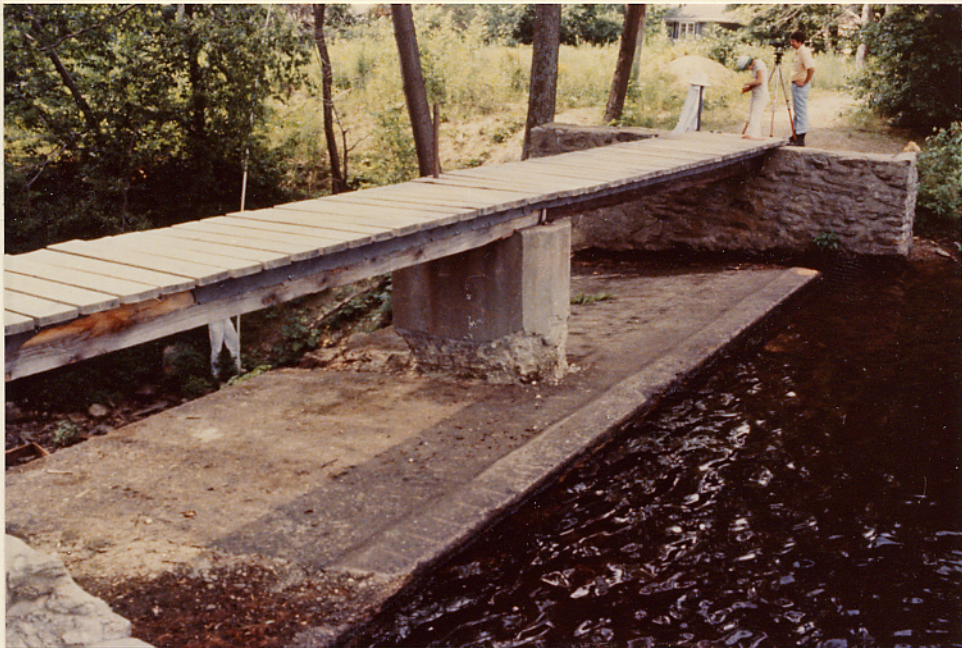
The concrete weir at the main spillway shows signs of severe erosion. The erosion downstream of the footbridge pier was probably caused by cavitation during supercritical flow due to the poor hydraulic design of the pier.

NO. 1 SPILLWAY WEIR

- (1) remove the blockage at the outlet pipe
- (2) repair the concrete on the spillway weir and pier
- (3) cut down trees and clear brush from the embankment to 20 feet downstream of the toe, from the sides of the downstream stream channel, and from the emergency spillway channel

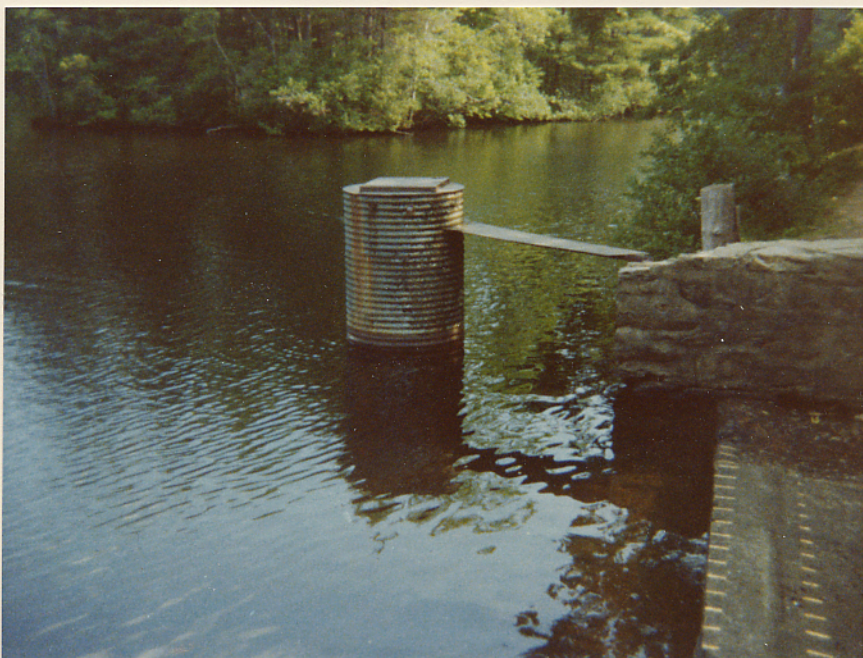
There is an outlet conduit located just east of the main spillway. The gate valve to the conduit was not operated during the inspection, and the conduit was not visible. A 1958 drawing (see Figure B-2 in Appendix B) indicates that it is a 12-inch diameter cast-iron pipe located 4 feet east of the main spillway. The invert of the conduit is estimated from the drawing to be 595.3 feet. The drawing shows a gate valve which is operated by a hand wheel and controls the flow into the conduit. The valve and wheel mechanism are enclosed in a circular, corrugated metal housing which is 4 feet in diameter. A metal cover is welded to the top of the housing and is secured by padlocks. The housing is located 8.5 feet upstream of the east wall of the spillway. A 6-inch wide metal plank provides access out to the housing from the spillway wall.

NO. 2 GATE HOUSE FOR OUTLET CONDUIT

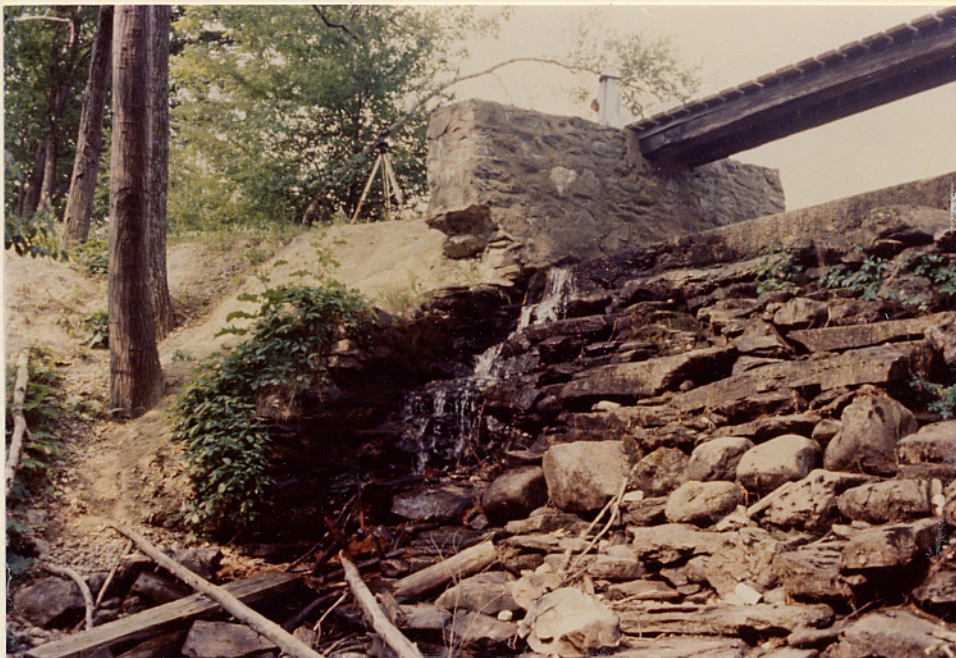
The upstream and downstream slopes on both sides of the main spillway are steep, sloping at 1:1. Trees along the downstream face of the embankment to the east are tilted downstream which could indicate creep of the slope. In addition, footpaths have been worn adjacent to the sides of the spillway, leaving unprotected earth slopes. The crest on both sides of the spillway is eroded, forming the lowest elevations of the top of the dam. The upstream face of the embankment is not protected with riprap, and local sloughing occurs east and west of the main spillway. Outcrops of granite bedrock were noted in the left abutment area.

NO. 3 WEST ABUTMENT OF SPILLWAY, DOWNSTREAM SLOPE

- (4) repair eroded areas of the upstream face of the dam face and protect with riprap or other suitable material
- (5) replace missing stonework from west wall of spillway and cascade

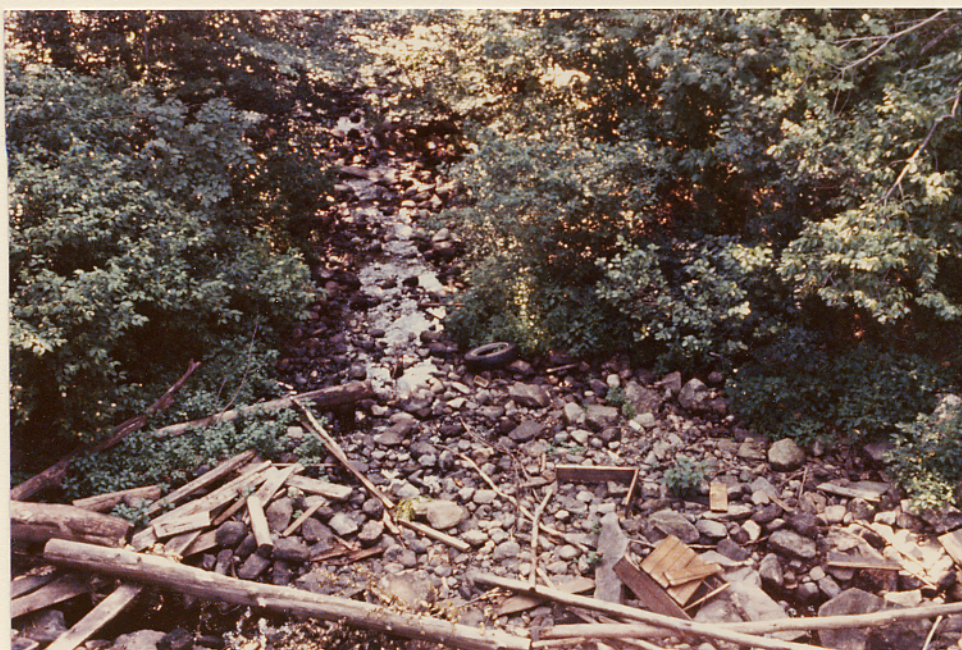
NO. 4 CHANNEL DOWNSTREAM OF SPILLWAY

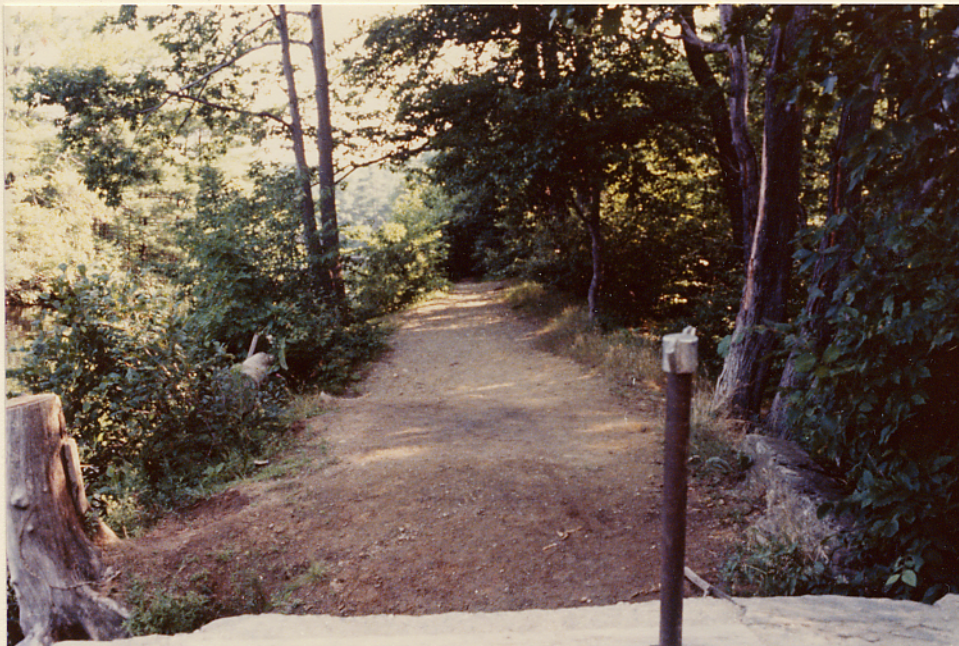
There is extensive tree and brush growth on both upstream and downstream slopes of the entire embankment. The footpath along the crest is worn and irregular.

NO. 5 DAM CREST EAST OF SPILLWAY

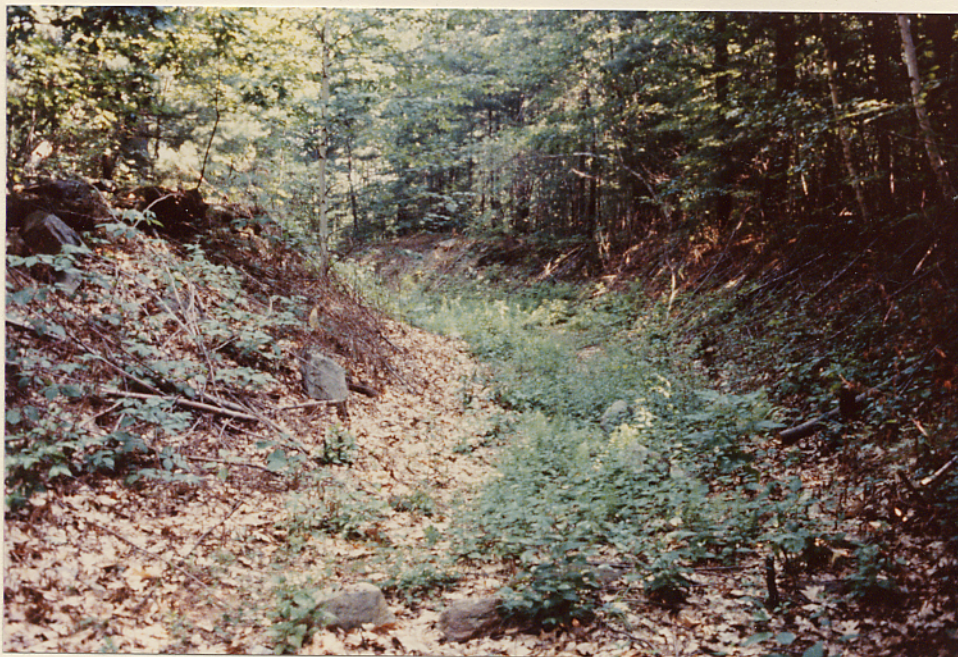
NO. 6 EMERGENCY SPILLWAY, VIEW LOOKING UPSTREAM
